Case Study: Belleview Oaks Estates

CSWR-Florida completed comprehensive upgrades to the Belleview Oaks Estates water treatment facility, addressing critical safety and operational issues to ensure reliable service for the community.

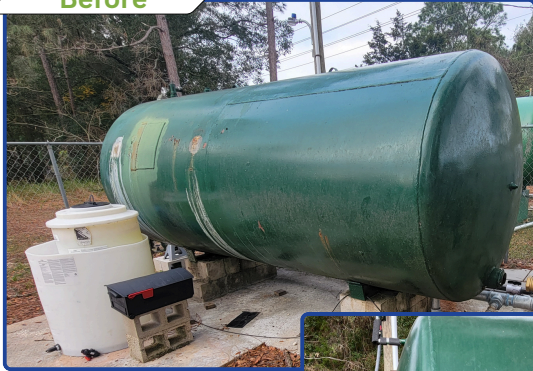
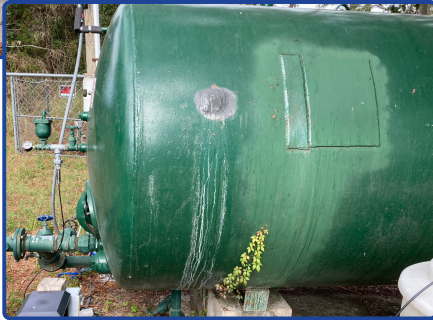
Before

When CSWR-Florida acquired the facility, it faced significant challenges, including a corroded tank, outdated electrical systems, no remote monitoring, and inadequate chemical containment that violated Florida Administrative Code. An abandoned well posed contamination risks, the site lacked lighting, a generator, and proper equipment housing, leaving it vulnerable to weather and tampering.

To address these deficiencies, CSWR-Florida implemented a series of targeted improvements. The abandoned well was plugged to eliminate contamination risks, and outdated electrical panels were upgraded to meet national and local safety codes. A continuous chlorine analyzer and remote monitoring systems were installed, allowing real-time water quality and equipment monitoring and proactive management. Floodlights now ensure safe site access after dark, while a newly installed emergency generator will prevent service interruptions from occurring during power outages.

Additional upgrades included chemical containment systems to prevent accidental releases, an eyewash station, and a fire extinguisher to enhance site safety. Outdated equipment was replaced, and modern monitoring systems were added to extend the facility's lifespan and ensure consistent water quality.
