**Case Study: Leon Springs**

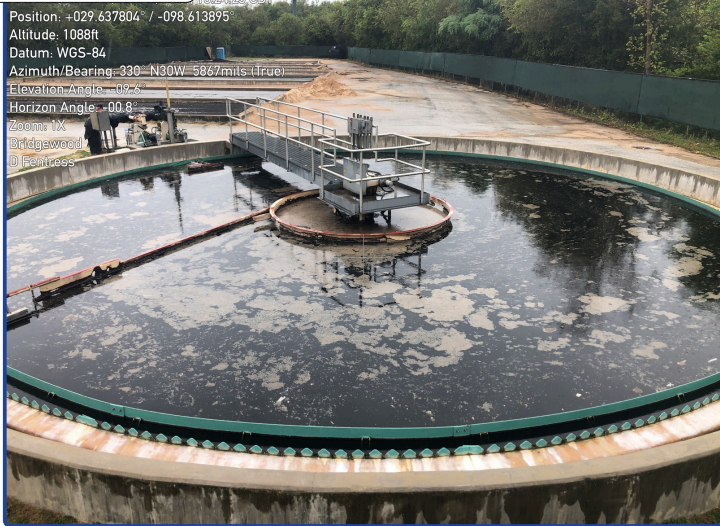
Before

Upon acquiring the Leon Springs wastewater system in Bexar County, CSWR-Texas discovered significant equipment failures and infrastructure decay. The system was beleaguered by damaged aeration basins, failing aerators, unreliable electrical systems, deteriorating lift station piping, and a severely corroded steel door in the chlorination room.

To address these issues, CSWR-Texas implemented a series of improvements, including the installation of remote monitoring hardware, an overhaul of the disinfection system, recoating of lift station piping, and the replacement of failed pumps. We also completed key clarifier repairs, including updates to the motor, drive assembly, catwalk, and skimmer arm. Additionally, the tertiary treatment system received a new filter, and the drying beds were rehabilitated, with above-ground equipment recoated as needed.
