Case Study: North Oak Sewer

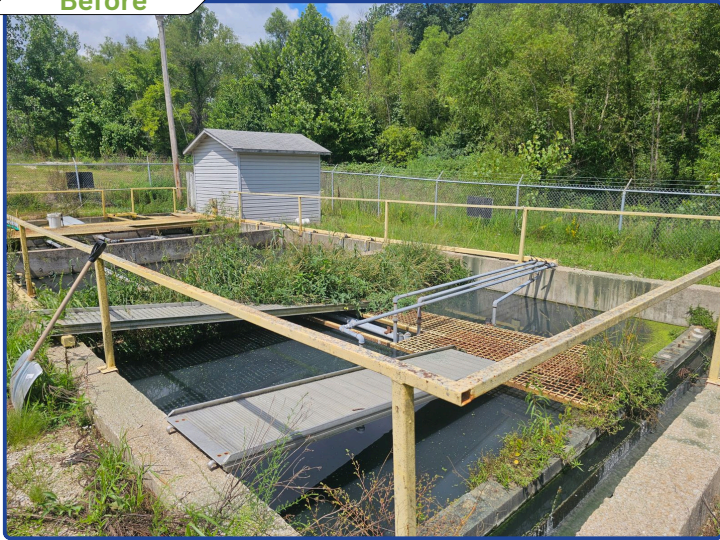
Before

When Confluence Rivers acquired the North Oak Sewer facility, the system was exceeding permit limits for BOD and E. coli. As an extended aeration activated sludge plant, it was designed for more robust treatment—but years of inadequate maintenance had left it underperforming. There was no dedicated disinfection process, serious solids accumulation had overwhelmed the clarifier, and the system lacked functional skimmers or scum handling. In one striking example of neglect, tomato plants had begun growing inside the treatment tanks, nourished by the built-up sludge.

Further complicating performance, the clarifier's outdated baffle wall created hydraulic issues that pushed solids to the surface, while deteriorating sludge return systems limited the plant's ability to manage biological solids effectively.

Confluence Rivers initiated a full-scale rehabilitation. Excess solids were removed, and the aging blower building was completely restored. New aeration blowers and control panels were installed to increase treatment efficiency. Sludge return and scum piping were replaced, and an upgraded influent screen was installed to remove debris from the incoming flow and protect downstream equipment.
