Case Study: Oakcrest Villas

CSWR-Florida completed critical upgrades to the Oakcrest Villas water treatment facility, addressing significant safety and compliance issues to ensure reliable service for the community.

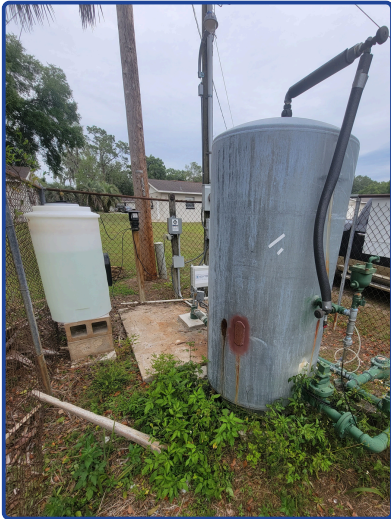
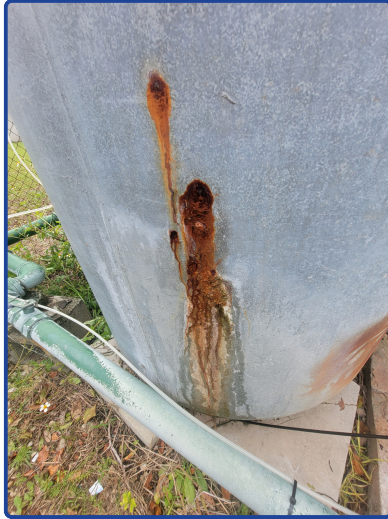
Before

At acquisition, the facility faced several challenges: the hydropneumatic tank was severely corroded with a patched leak, no exterior coating, and no sight glass for level monitoring. Exposed wiring on the well pump violated Florida Administrative Code by leaving the casing vulnerable to contamination. The site also lacked proper chemical containment and had no protective building to house sensitive equipment like logbooks or chemical pumps.

Additionally, concerns included no floodlights for nighttime access, no emergency generator for backup power, and no remote monitoring system to track performance or alert staff to issues.

CSWR-Florida implemented a comprehensive plan to address these deficiencies. The corroded hydropneumatic tank was replaced, exposed well pump wiring was repaired, and a continuous chlorine analyzer with remote monitoring was installed for real-time water quality, equipment monitoring, and proactive management. Electrical systems were upgraded to meet safety codes, floodlights were added for improved security, and chemical containment systems were installed to prevent accidental releases, ensuring regulatory compliance.

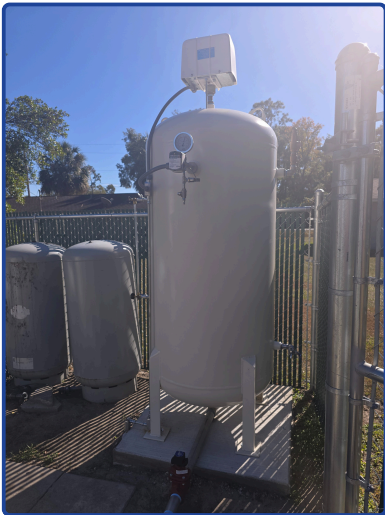
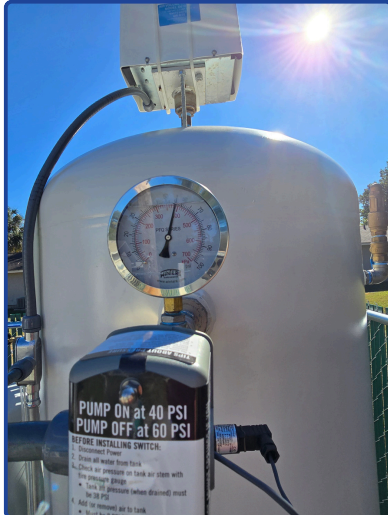
After

These improvements have transformed the Oakcrest Villas facility into a safer, more efficient operation. The community can now depend on a water treatment system designed for safety, reliability, and sustainability.
