Case Study: Riverscape Wastewater System

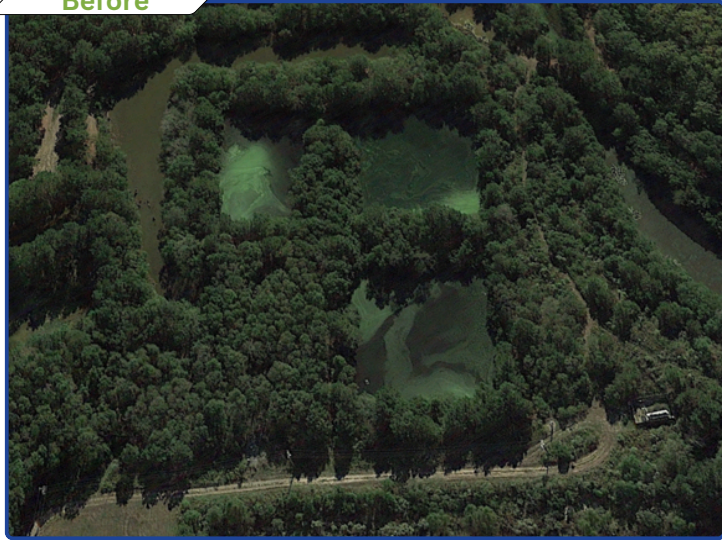
Before

At acquisition, the Riverscape facultative lagoon bore no resemblance to a wastewater functioning treatment facility. Overgrown with vegetation and filled with untreated sewage, the site lacked even the most basic equipment required for wastewater processing—posing a serious threat to public health and the environment.

To bring the facility into compliance with stringent effluent limits, Magnolia Water initiated a complete transformation. The site was first cleared of excessive vegetation, allowing for safe access and operational visibility. A moving bed biofilm reactor (MBBR) was installed to provide advanced biological treatment, supported by a new aeration system to ensure sufficient oxygen transfer. A tertiary strainer was added to further polish the effluent and meet regulatory standards for discharge.

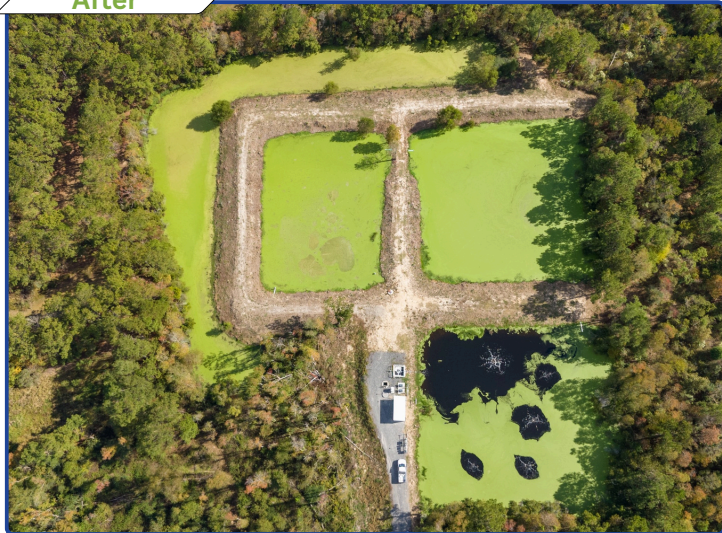
After

In a short period, Magnolia turned the Riverscape facultative lagoon from a stagnant, untreated pond into a functional treatment facility capable of delivering safe, compliant wastewater service—demonstrating the power of targeted investment and environmental responsibility.
