Case Study: Sunlight Acres Subdivision

CSWR-Florida completed essential improvements to the Sunlight Acres Subdivision water treatment facility, addressing long-standing deficiencies to provide residents with safe, reliable water service.

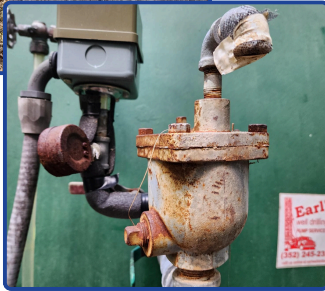
Before

When CSWR-Florida acquired the facility, it faced numerous challenges. The hydropneumatic tank was severely corroded, and the electrical panels were deteriorated and urgently needed replacement. The site had no fire extinguisher, floodlights, or proper chemical containment and disinfection equipment housing, leaving it vulnerable to equipment damage, safety risks and environmental violations. Additionally, the system lacked remote monitoring and an emergency generator, creating potential hazards and operational inefficiencies.

To address these issues, CSWR-Florida implemented a comprehensive series of upgrades. The corroded hydropneumatic tank was replaced with a new tank, ensuring long-term reliability. A continuous chlorine analyzer and remote monitoring system were installed, enabling real-time water quality, equipment monitoring and proactive management. Corroded electrical components were replaced to meet safety standards, and chemical containment systems were added to prevent accidental releases. A leaking blowoff valve was replaced, and a backup generator was installed to ensure uninterrupted service during power outages.
