Case Study: The Woodlands Water System

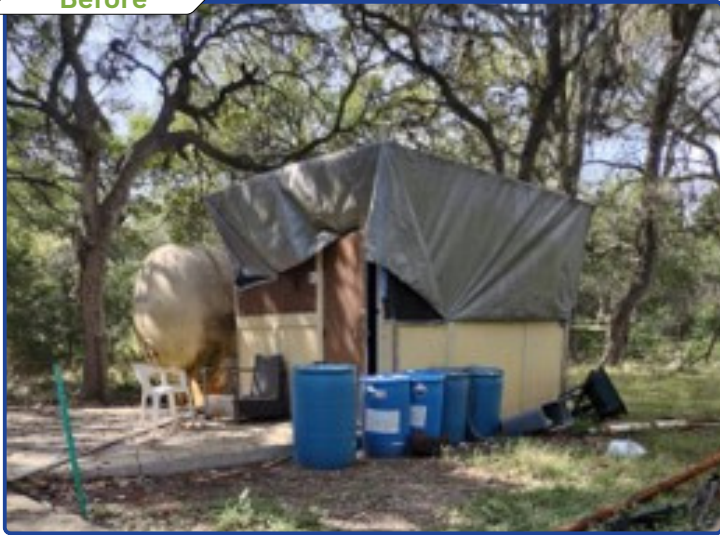
Before

The hydropneumatic tank, which had suffered from a damaged interior coating, was recoated to restore its functionality and increase its usable lifespan. To further enhance the system's infrastructure, the service pump housing building was given a full refurbishment. This included repainting the building, repairing its walls, and replacing the roof, ensuring that it remains in good condition and protected from future damage.

One of the primary improvements was the addition of much-needed ground storage and service pump capacity, enhancing the system's ability to store and distribute water efficiently. In addition, all above-ground equipment was replaced and coated for UV protection, safeguarding it against the elements and increasing its durability.
