Case Study: Winding Waters Subdivision

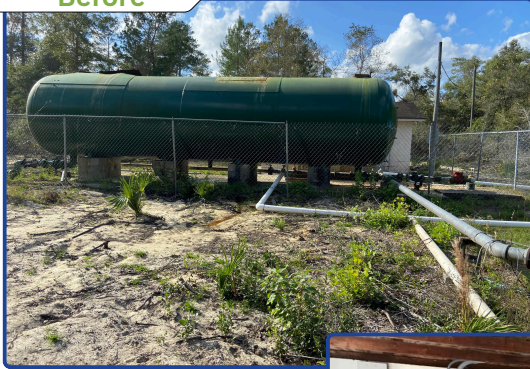
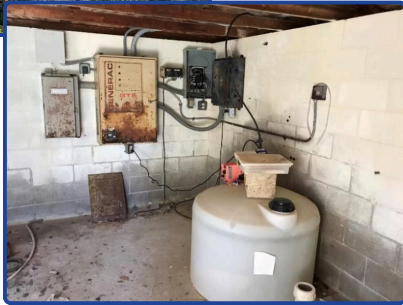
Before

When CSWR-Florida acquired the Winding Waters Subdivision water treatment facility, it faced numerous challenges that threatened operational safety and compliance. The hypopneumatic tank was severely corroded with failing interior coating, and the air injection system relied on outdated and unreliable methods. Well 1 had leaking components, and Well 2 lacked proper fencing and venting, leaving it exposed to contamination risks. The well house, degraded by chlorine off-gassing and weather exposure, lacked a door, chemical containment, fire extinguishers, and adequate lighting. Electrical systems and the automatic transfer switch were in disrepair, the generator was nearing the end of its useful life, and there was no remote monitoring or continuous chlorine analyzer for oversight. Additionally, the access road to the wells was overgrown and impassable.

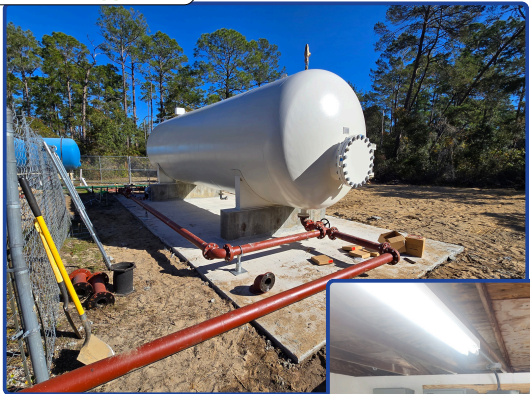
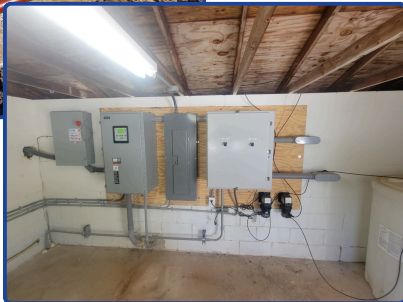
After

To address these deficiencies, CSWR-Florida implemented a comprehensive improvement plan. The corroded hypopneumatic tank was replaced, and chemical containment systems were installed to protect against spills and environmental risks. Remote monitoring and a continuous chlorine analyzer were added to provide real-time oversight and water quality tracking. Electrical upgrades brought the facility into compliance with safety standards, and the malfunctioning automatic transfer switch was replaced. Floodlights were installed to enhance site accessibility and security, and a new access road was constructed to facilitate maintenance. Finally, the aging generator was replaced, ensuring reliable standby power in compliance with Florida Administrative Code.

These upgrades have transformed the Winding Waters Subdivision water treatment facility into a modern, compliant operation that provides the community with safe and reliable drinking water. With enhanced infrastructure, proactive monitoring, and streamlined access, the system is now equipped to meet both current and future needs.
