## Case Study: Herrington Haven

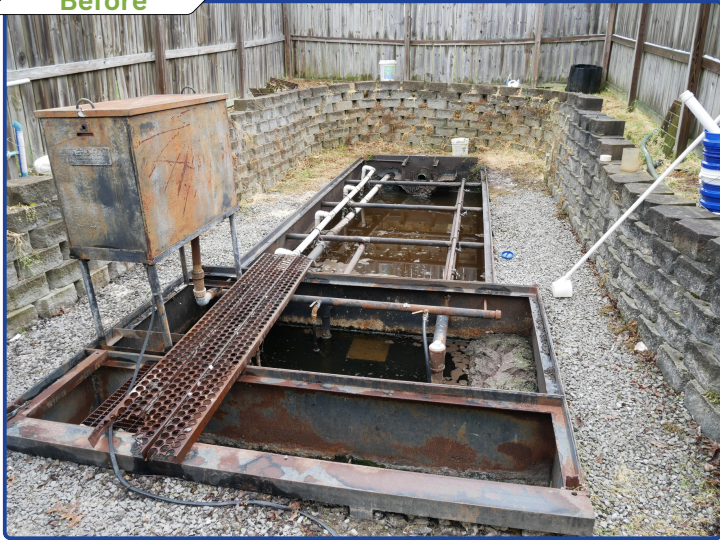
Before

At the time of acquisition, the Herrington Haven wastewater facility was operating with treatment equipment well past the end of its useful life. The aging infrastructure could no longer provide effective treatment, and the facility was unable to consistently meet its permitted effluent limits.

To restore compliance and improve reliability, Bluegrass Water implemented a full suite of upgrades. New blowers and Integrated Fixed-Film Activated Sludge (IFAS) caged aeration units were installed to enhance treatment performance, while a new digester improved solids handling and overall system efficiency. A new lift station was also added to support consistent flow management throughout the treatment process.

In addition to these operational upgrades, secured handrails were installed across the site to improve worker safety and accessibility. With these enhancements, the Herrington Haven facility is now operating reliably, performing within permit standards, and positioned for long-term stability and compliance.
