### Case Study: Indian Hills

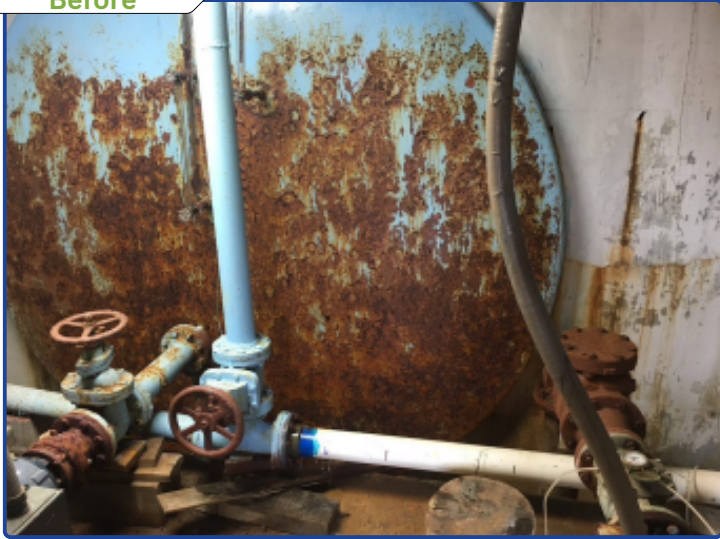
Before

At the time of acquisition, the Indian Hills water system in Crawford County was plagued by constant leaks and reliability issues. The distribution network had been built decades earlier from outdated commercial irrigation lines, and the deteriorated materials could no longer support consistent service. Meanwhile, the well sites themselves were in poor condition, with underperforming pumps and inadequate storage, further straining the system.

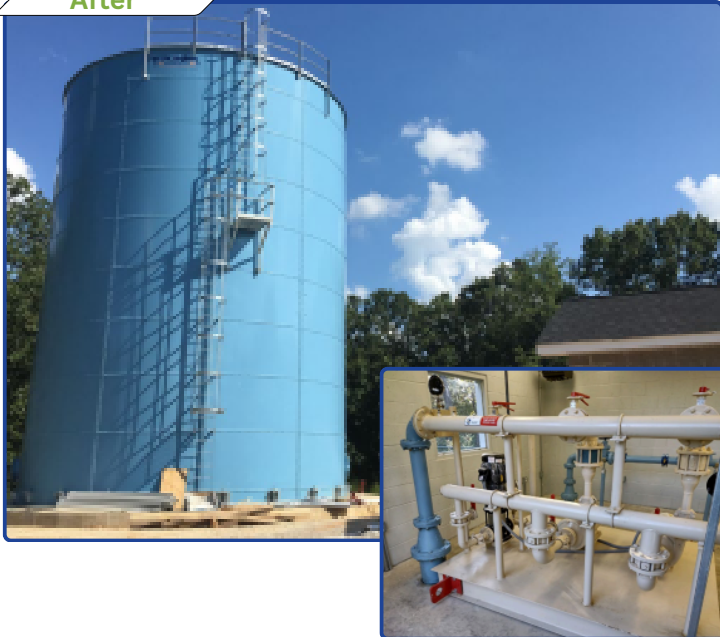
After

Initial improvements targeted the well sites where repairs and new storage capacity boosted system pressure. However, the stronger pressure only underscored the fragility of the aging distribution lines, triggering cascading failures across the network. The system's original infrastructure was simply unable to keep pace with the demands of a modern water supply.

To restore stability, the entire distribution system was systematically replaced, eliminating leaks and bringing reliable service back to the community. With modern infrastructure now in place, Indian Hills residents benefit from consistent water delivery and a system positioned for long-term reliability, supported by ongoing maintenance and future improvements as needed.
