Case Study: Cajun Estates

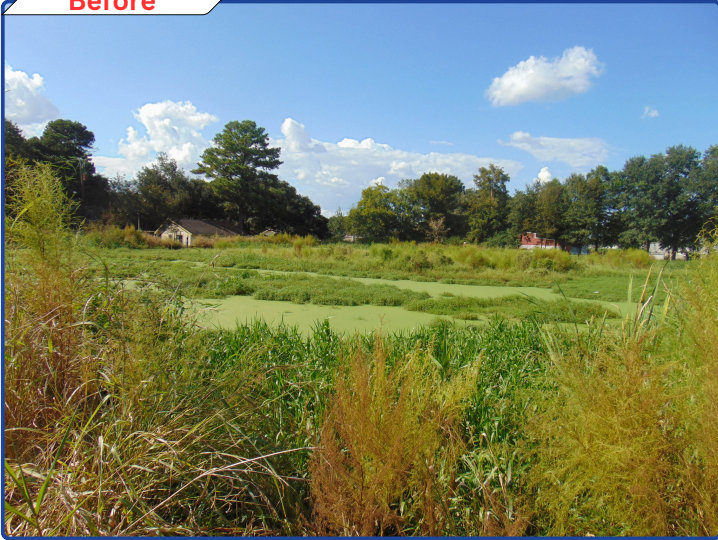
Before

At the time of acquisition, the Cajun Estates lagoon system was experiencing **ongoing treatment challenges**, with a history of **frequent violations**. The lagoons were heavily impacted by vegetation overgrowth, with dense growth along the berms and within the pond, particularly in the primary cell, hindering proper treatment and overall system performance.

In addition to treatment limitations, **structural concerns** were present. The berm along the southeastern edge of the second pond showed signs of **deterioration**, resulting in **seepage** that extended into a neighboring property and raised **environmental and community concerns**.

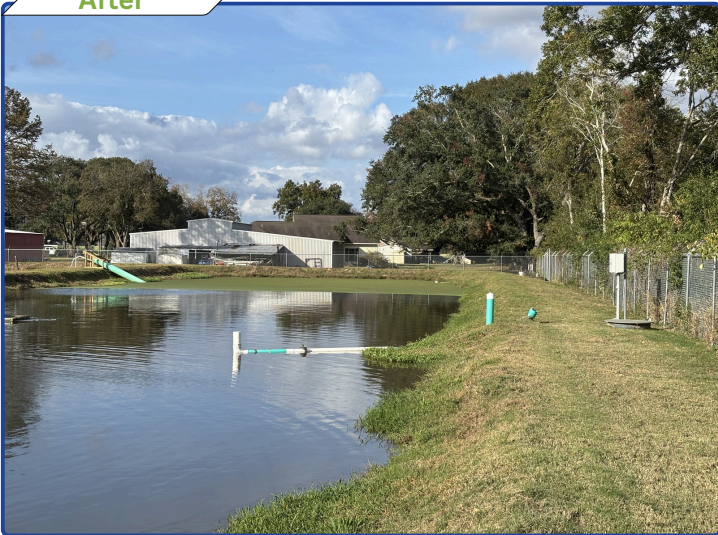
After

To restore the system, Magnolia Water implemented **targeted improvements** focused on both **treatment performance** and **structural integrity**. Extensive vegetation removal was carried out across the site, reestablishing proper lagoon function and allowing the treatment process to operate as intended. **Berms were repaired and stabilized**, eliminating seepage and protecting adjacent properties.

To further enhance treatment, an **MBBR and clarifier system** were installed and brought online. These upgrades significantly **improved biological treatment** and **solids removal**, providing the capacity needed for **consistent, compliant operation**.

The results have been substantial. **Average BOD levels have decreased by more than 83%**, while **total suspended solids were reduced by over 93%**, bringing the system into **compliance** and significantly improving effluent quality.
