## Case Study: Cajun Estates

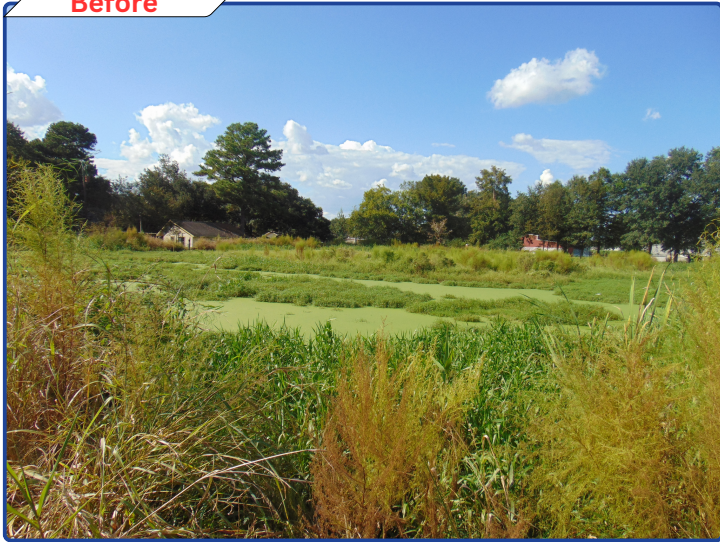
Before

At the time of acquisition, the Cajun Estates lagoon system was experiencing **ongoing treatment challenges**, with a history of **frequent violations**. The lagoons were heavily impacted by vegetation overgrowth, with dense growth along the berms and within the pond, particularly in the primary cell, hindering proper treatment and overall system performance.

In addition to treatment limitations, **structural concerns** were present. The berm along the southeastern edge of the second pond showed signs of **deterioration**, resulting in **seepage** that extended into a neighboring property and raised **environmental and community concerns**.

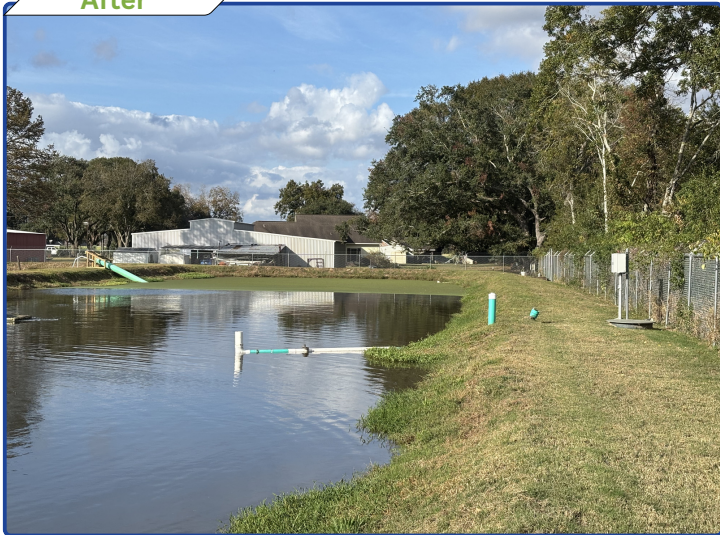
After

To restore the system, Magnolia Water implemented **targeted improvements** focused on both **treatment performance** and **structural integrity**. Extensive vegetation removal was carried out across the site, reestablishing proper lagoon function and allowing the treatment process to operate intended. **Berms were repaired and stabilized**, eliminating seepage and protecting adjacent properties.

To further enhance treatment, an **MBBR and clarifier system** were installed and brought online. These upgrades significantly **improved biological treatment** and **solids removal**, providing the capacity needed for **consistent, compliant operation**.

The results have been substantial. **Average BOD levels have decreased by more than 83%**, while **total suspended solids were reduced by over 93%**, bringing the system into **compliance** and significantly improving effluent quality.
