Case Study: Cherrywood Lone Oak

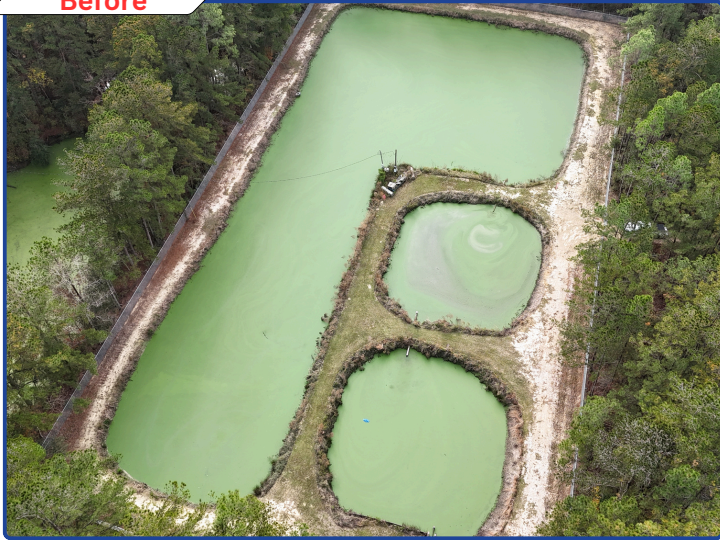
Before

At the time of acquisition, the Cherrywood wastewater lagoon system was operating with **aging equipment that could no longer effectively treat wastewater**. The system had a history of **exceeding permit limits**, with insufficient treatment performance allowing inadequately treated discharges to contaminate nearby streams.

To address these challenges, Magnolia Water implemented **targeted upgrades** to restore compliance and improve overall system performance. An **MBBR and clarifier system were installed**, significantly enhancing the biological treatment process and solids separation. These improvements provided the necessary treatment capacity to **meet regulatory requirements** and stabilize operations.

In addition, the **chlorine contact tank was replaced to ensure proper disinfection** of treated effluent. This upgrade strengthened the system's ability to consistently meet disinfection standards and **protect downstream water quality**.

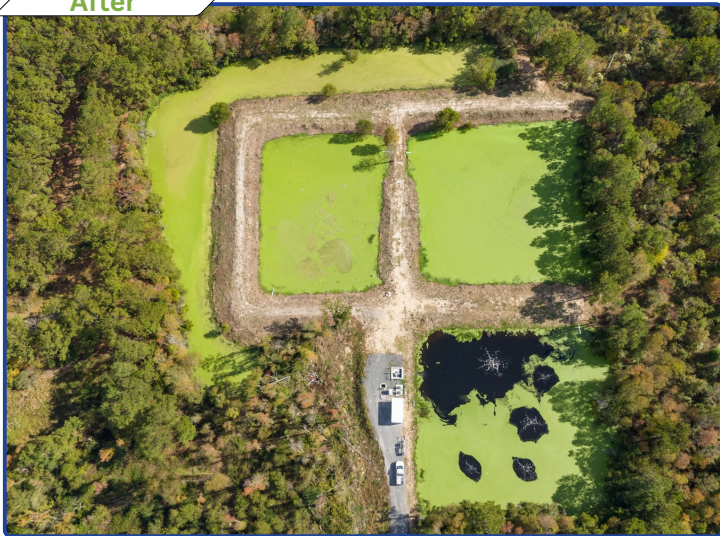
After

Following these improvements, the system's performance improved dramatically. **Average BOD levels dropped by more than 84%**, bringing the facility back into **compliance** and restoring **safe, reliable wastewater treatment**.
