Case Study: Green Bayou

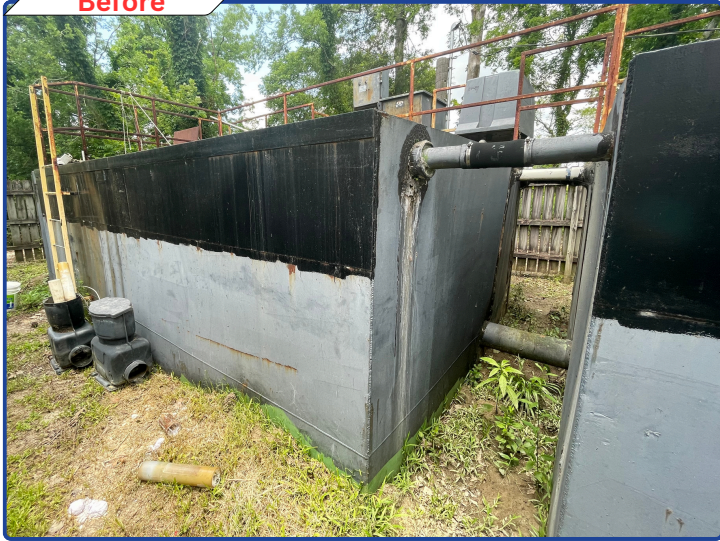
Before

At the time of acquisition, the Green Bayou wastewater treatment facility was **structurally compromised** and well beyond its useful life. Much of the internal steel components—including tanks, handrails, and the bar screen—were severely **rusted and deteriorated**. The site was further impacted by broken fencing, overgrown vegetation, and fallen debris, creating both **operational and safety concerns**.

The facility's condition contributed to ongoing treatment challenges and **repeated permit violations**, underscoring the need for a comprehensive solution rather than incremental repairs.

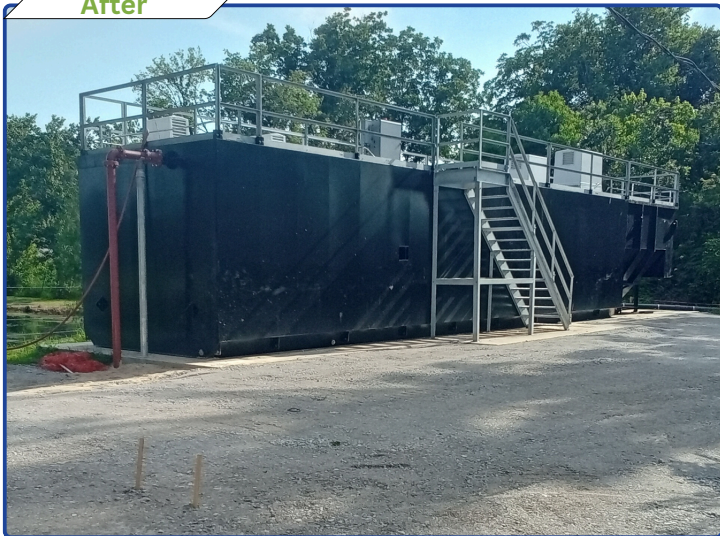
After

To address these issues, Magnolia Water **fully replaced the existing plant** with a **new steel treatment facility**. The original structure was decommissioned and removed, and the disturbed areas were restored—resulting in a **safer, more modern, and fully functional treatment site**.

With the new facility in place, treatment performance improved significantly. **Average BOD levels dropped by nearly 90%**, restoring compliance and ensuring reliable wastewater treatment.
