## Case Study: Payne

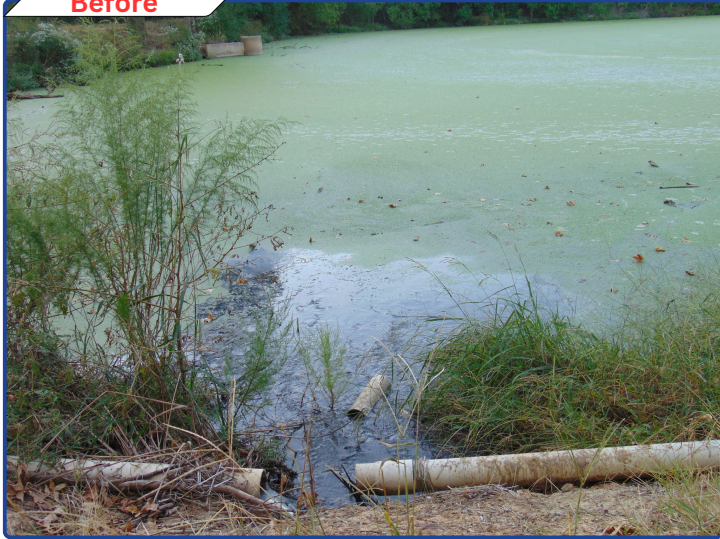
Before

At the time of acquisition, the Payne wastewater system was experiencing ongoing treatment challenges, with a history of **repeated permit violations** and inconsistent performance.

To address these issues, Magnolia Water implemented **targeted upgrades** to improve treatment reliability and bring the system back into compliance. An **MBBR and clarifier system** were installed, enhancing biological treatment and solids removal. In addition, the **chlorine contact tank** was replaced to ensure proper disinfection and strengthen overall treatment performance.

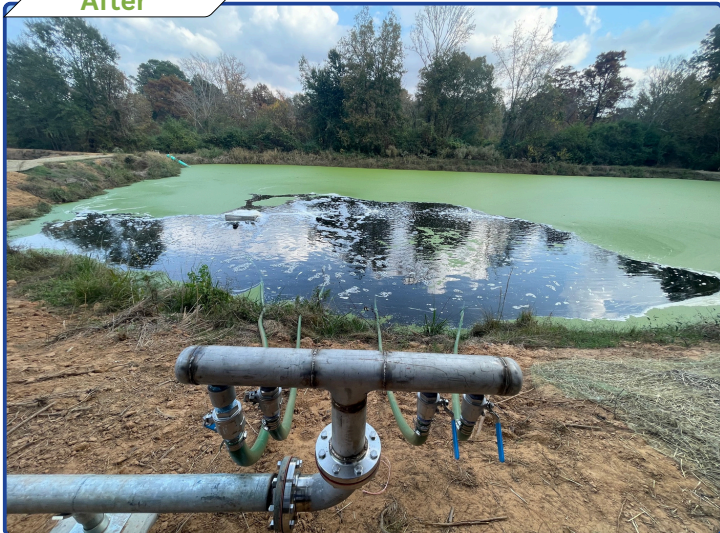
After

Following these improvements, the system saw significant gains in performance. **Average BOD levels were reduced by more than 80%**, while **solids levels decreased by nearly 80%**, restoring compliance and improving operational reliability.

Today, the Payne system operates as a **stable and dependable wastewater treatment facility**, reflecting Magnolia Water's commitment to **targeted infrastructure improvements** and **long-term system performance**.
