## Case Study: Shangrila

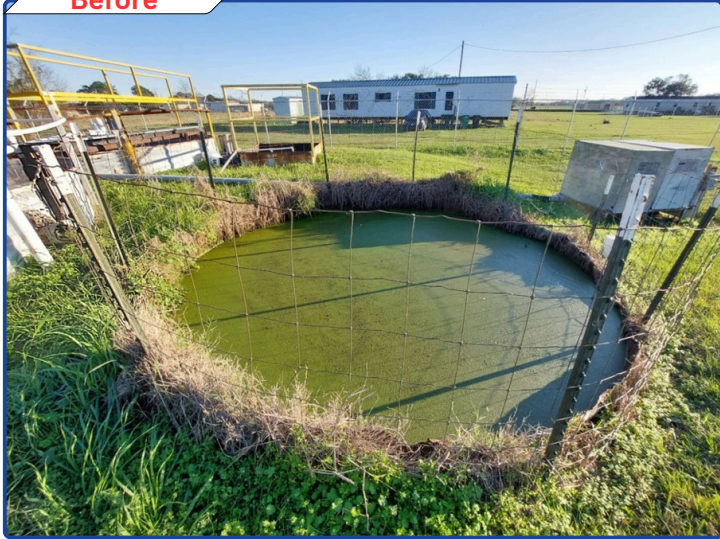
Before

At the time of acquisition, the Shangrila wastewater treatment facility was in a **severely distressed condition** and well beyond its useful life. The existing grain bin-style plant was leaking, with multiple tanks showing signs of imminent failure, creating significant reliability and operational concerns.

The condition of the facility contributed to ongoing treatment challenges and inconsistent performance, signaling the need for a **long-term, sustainable solution**.

To address these issues, Magnolia Water replaced the aging structure with a **new concrete wastewater treatment plant**. This upgrade provides a more **durable, long-lasting solution** while reducing ongoing maintenance needs and improving overall **system reliability**. In addition, key lift station components were overhauled to strengthen performance and reduce the risks of collection system backups.

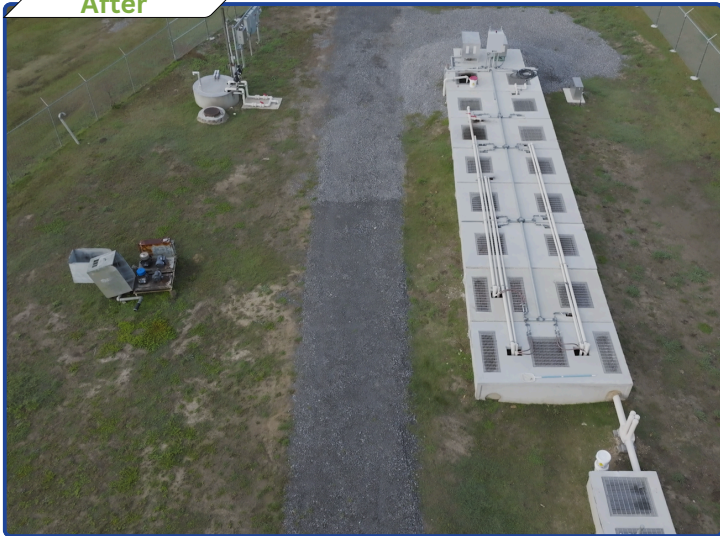
After

Following these improvements, treatment performance improved substantially. **Solids levels were reduced by more than 85%**, bringing the system back into compliance and restoring **dependable operation**.

Today, the Shangrila system operates as a **stable and efficient facility**, reflecting Magnolia Water's commitment to investing in **resilient infrastructure** and delivering **reliable wastewater service** to the communities it serves.
