Case Study: Amberwoods Subdivision

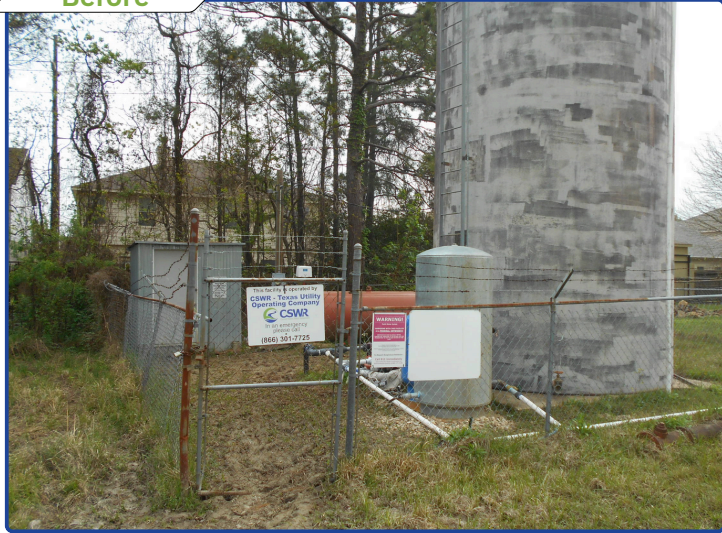
**Before**

CSWR-Texas completed a comprehensive overhaul of the Amberwoods Water Treatment System in Harris County to bring the facility into full compliance with regulatory standards. Prior to these improvements, the system faced aging infrastructure and outdated equipment, which impacted its overall performance and reliability.

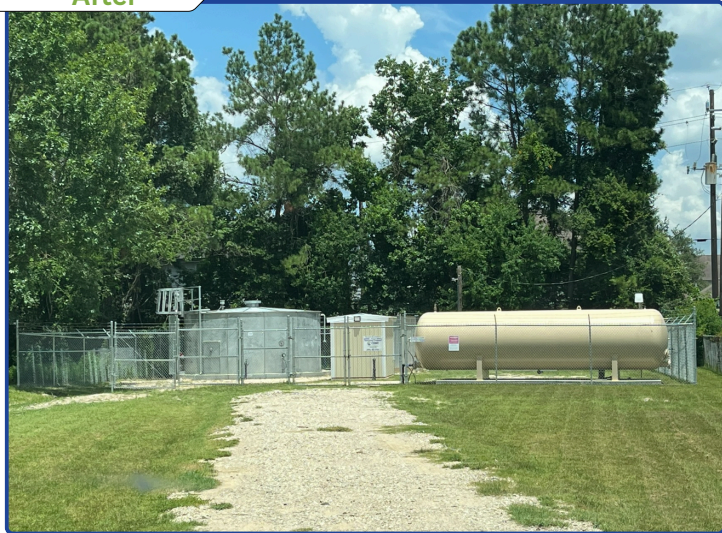
**After**

One of the key upgrades included the installation of a new 16,000-gallon ground storage tank, enhancing the system's storage capacity and ensuring a more reliable water supply. The existing hydropneumatic tank was replaced to improve pressure regulation and system efficiency. Additionally, new housing for the service pumps was installed to extend their expected lifespan, reducing the risk of breakdowns and ensuring smoother operation.

Electrical improvements were also made to support the new equipment, ensuring that the system runs efficiently and effectively. To protect the integrity of the system and extend its operational life, all onsite assets were recoated or replaced with UV-resistant materials.

These upgrades have significantly improved the Amberwoods Water Treatment System's reliability and performance, providing safe, consistent water service to the community. The successful completion of these enhancements has ensured that the system now operates in compliance with all relevant standards and is better equipped to serve the residents of Amberwoods for years to come.
