Case Study: Coletto

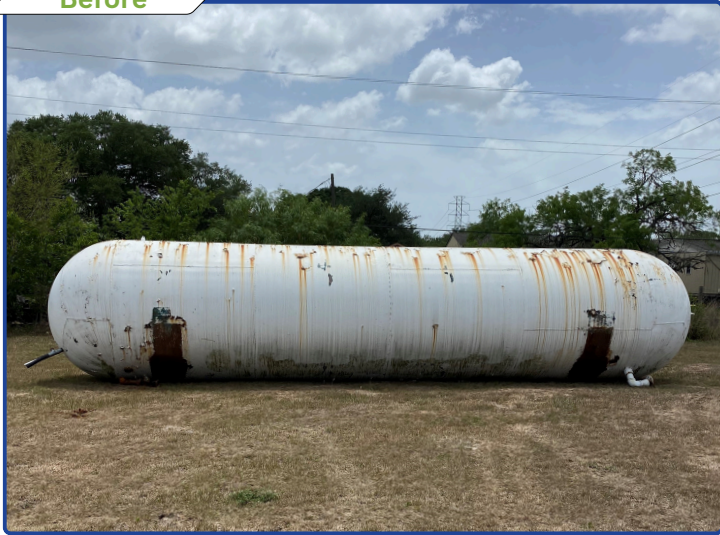
Before

In 2022, CSWR-Texas completed capital improvements on the Coletto Water system in Texas. When we purchased this system, it had been suffering from years of neglect and lack of reinvestment. The 44,000-gallon ground storage tank had severe corrosion and multiple leaks. The hydropneumatic tank also faced severe corrosion and had no access hatch, rendering an interior inspection of the tank impossible. CSWR-Texas removed the ground storage tank and installed a new fiberglass tank. The hydropneumatic tank was also replaced.
