Case Study: Laguna Tres Water System

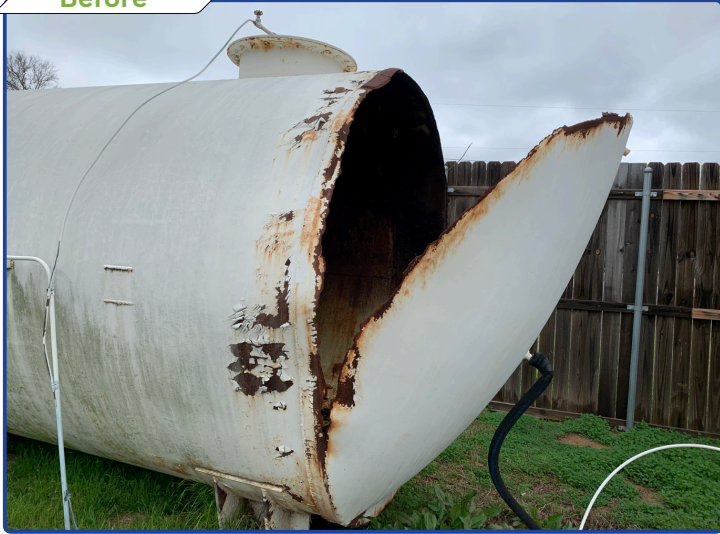
Before

CSWR-Texas performed critical repairs to the Laguna Tres Water System in Hood County, addressing significant issues with aging infrastructure that had been impacting the system's efficiency. One of the primary concerns was the original hydro-pneumatic tank, which was deteriorated beyond use and inactive, posing a risk to the system's ability to maintain proper water pressure.

CSWR-Texas replaced the damaged hydro-pneumatic tank with a new, operational unit to restore system functionality. In addition, repairs were made to the ground storage tanks, ensuring they were in optimal condition to store water and support the overall system. While contractors were onsite, the well header and casing were also recoated, which will extend the life of the equipment and protect it from wear and environmental factors.
