Case Study: Lake Virginia

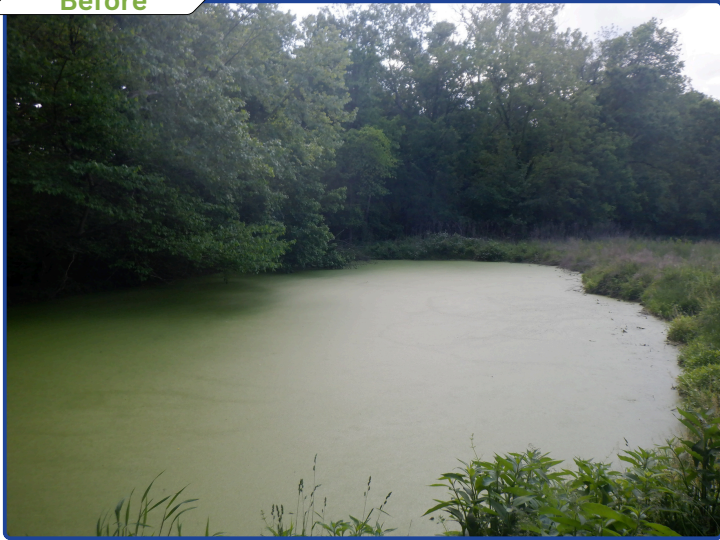
Before

At the time of acquisition, the Lake Virginia wastewater system was in a state of disrepair, marked by serious environmental and regulatory violations. The site included two lagoon systems—yet only one was permitted. The second lagoon was illegally discharging into nearby surface water, threatening local ecosystems and placing the facility in direct violation of Missouri environmental regulations. The permitted lagoon, a single-cell unit with no aeration or disinfection, consistently failed to meet ammonia and E. coli limits outlined in its permit.

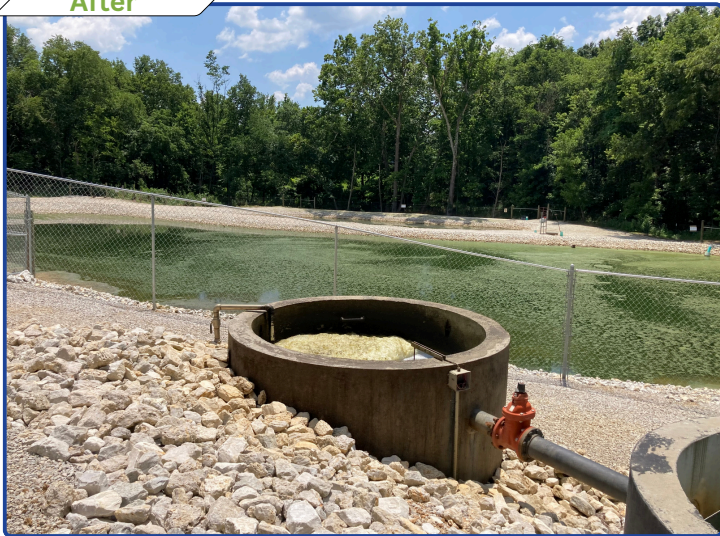
After

With these targeted upgrades and a renewed focus on operational oversight, the Lake Virginia facility is now fully compliant with state regulations and performing reliably. Confluence Rivers' investment not only resolved immediate violations but also strengthened long-term protections for Missouri's waterways and the community that depends on them.

Confluence Rivers acted quickly to stabilize the system and restore compliance. The unpermitted lagoon was repurposed as a holding cell to provide additional capacity during peak flows, effectively halting its illegal discharge. The permitted lagoon was reshaped and reinforced with rock to improve structural integrity and treatment flow. Most notably, a new Moving Bed Biofilm Reactor (MBBR) system was installed to enhance biological treatment and significantly improve ammonia removal. To address ongoing disinfection concerns, a tablet chlorination system was also added to ensure consistent and effective control of E. coli levels.
