Case Study: Mapaville Meadows

After years of violations and aging equipment, Confluence Rivers brings overdue upgrades to Mapaville Meadows. Built in the early 1980s and serving just nine connections, the Mapaville Meadows wastewater system had long struggled with persistent compliance issues. For years, the facility recorded permit violations for BOD, E. coli, and ammonia—markers of ineffective treatment that posed a risk to public health and the environment. Despite having adequate capacity, the plant suffered from poor aeration design, unreliable disinfection, and deteriorating infrastructure that undermined its overall performance.

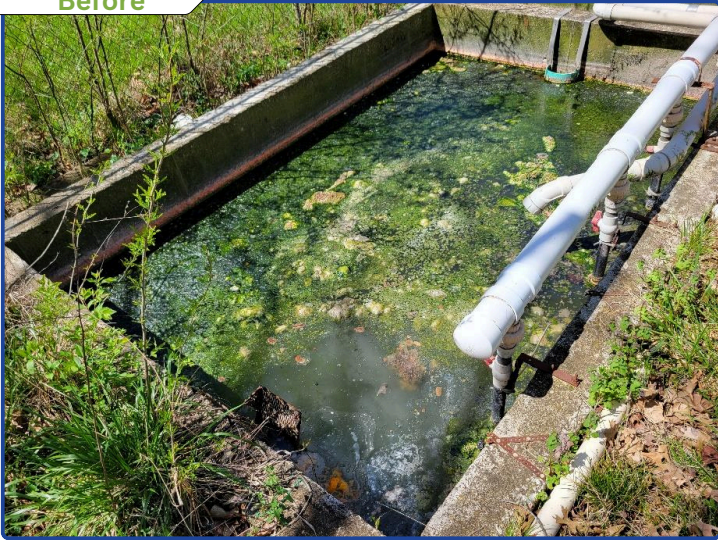
Before

At the time of the acquisition, the system operated with a single blower, a non-functional chlorine tablet feeder, and undersized clarifiers that regularly experienced washout. All process piping was above ground, made of plastic vulnerable to sunlight and mechanical failure. These vulnerabilities left the system ill-equipped to meet regulatory standards or reliably serve its customers.

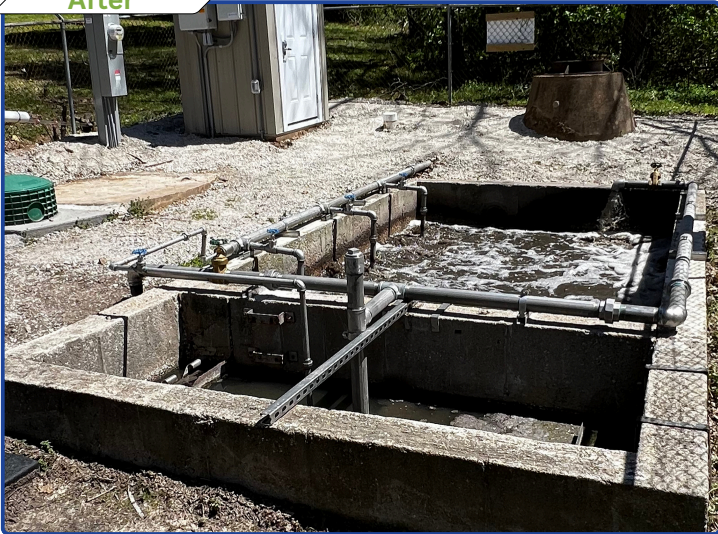
After acquiring the facility, Confluence Rivers initiated a focused rehabilitation effort to bring the system back into compliance. A new blower was installed to improve aeration, accumulated solids were removed from treatment units, and the aeration system was redesigned to support proper oxygen transfer. Plastic piping was replaced with durable stainless steel, and remote monitoring equipment was added to provide real-time performance data. Repairs and replacements were made to clarifier equipment to improve solids handling and prevent washout.

Further upgrades are currently underway, including the installation of a new chlorine tablet feeder and contact chamber to provide consistent disinfection—one of the system's most critical needs.
