### Case Study: Terre Du Lac Three-Cell Lagoon

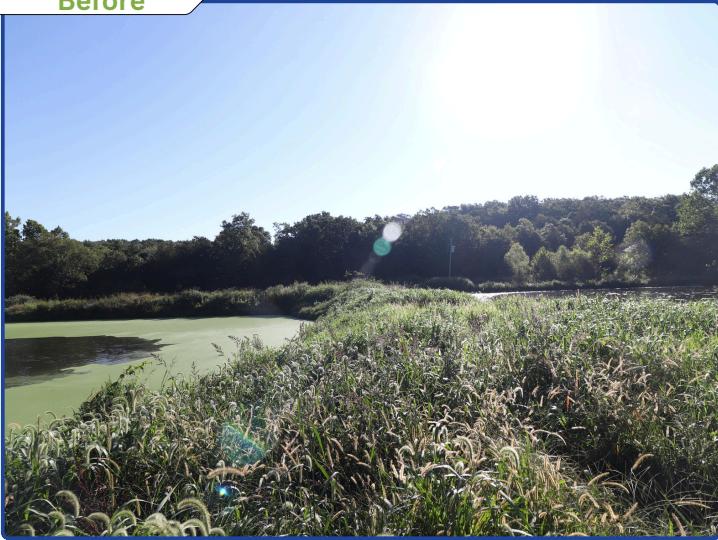
Before

At the time of acquisition, the three-cell lagoon serving part of the Terre Du Lac community was in poor condition and facing a range of operational and environmental challenges. The first cell was nearly filled with sludge, and the facility was routinely exceeding permit limits for ammonia and E. coli. Inoperable aerators further limited treatment performance, and with stricter standards for BOD and TSS on the horizon, the lagoon's deteriorating condition posed an increasing threat to both public health and water quality.

Additional site concerns included damaged berms, deteriorating fencing, and the lack of flow monitoring or backup power—factors that further compromised the reliability of the system.

Confluence Rivers responded with a comprehensive plan to restore stability and bring the lagoon system back into compliance. Berms were repaired and reinforced with rock armoring to prevent erosion, and perimeter fencing was replaced following tree removal. A new electrical panel was installed, and an advanced attached growth treatment system was added to enhance biological treatment. Enzyme treatment was also used to reduce sludge levels by approximately six feet—dramatically increasing lagoon capacity and treatment effectiveness.

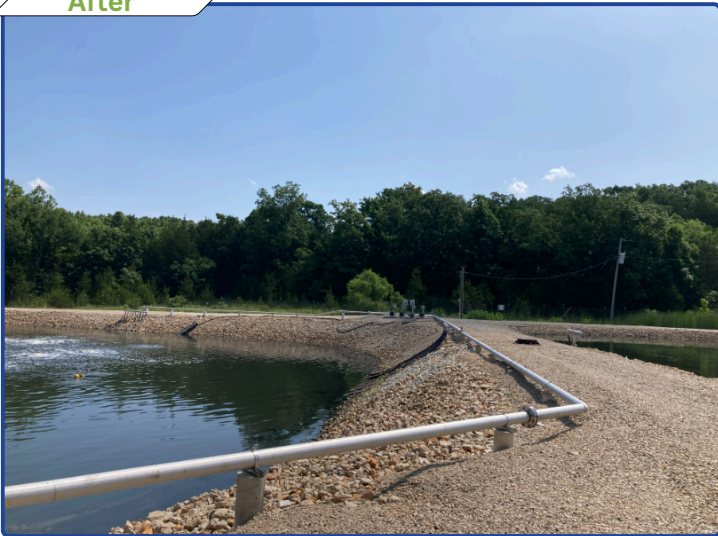
After

With these targeted improvements, the Terre Du Lac three-cell lagoon is now stabilized, significantly improved in performance, and positioned for long-term environmental compliance.
