Case Study: Terre Du Lac Water

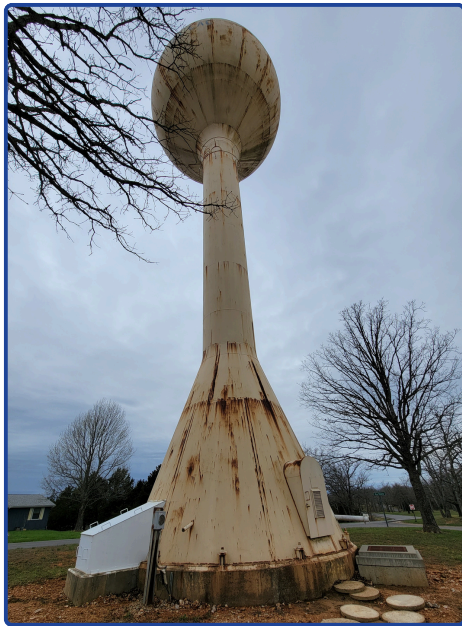
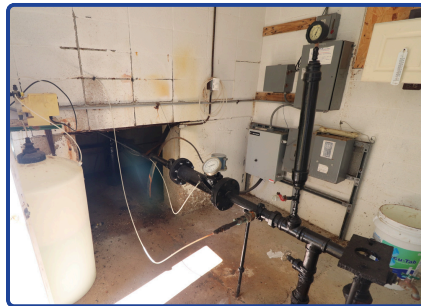
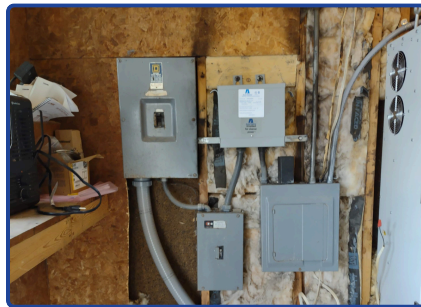
Before

In the Terre Du Lac community the drinking water system was in a state of disrepair at the time of acquisition. The well sites had faced major deficiencies—outdated disinfection systems, corroded equipment, and exposed electrical wiring posed serious safety risks and left the system vulnerable to failure. One well had even been taken offline after testing revealed unsafe levels of radionuclides. Meanwhile, the community's elevated storage tanks, some dating back to the 1960s, were significantly deteriorated and missing key safety features.

Confluence Rivers initiated a full-scale rehabilitation of the system. Two well houses were demolished and rebuilt from the ground up, equipped with upgraded pumps and motors, new chlorination systems, modernized electrical infrastructure, and remote monitoring capabilities. Flow meters and chlorine analyzers were added to improve real-time oversight of water quality, and backup generators were installed to maintain service during power outages. Both elevated storage tanks were inspected, recoated, and brought up to current safety standards to extend their useful life.

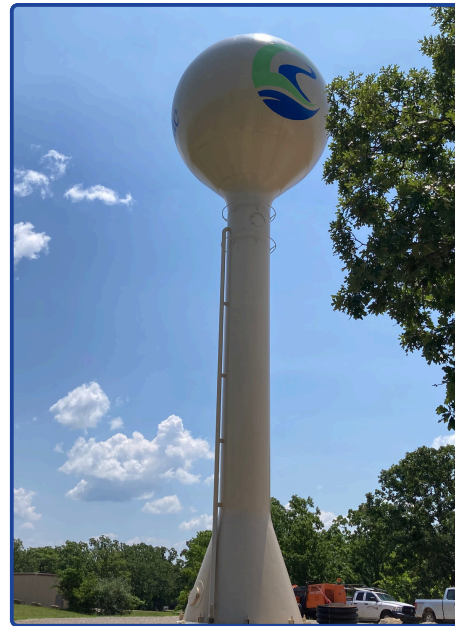
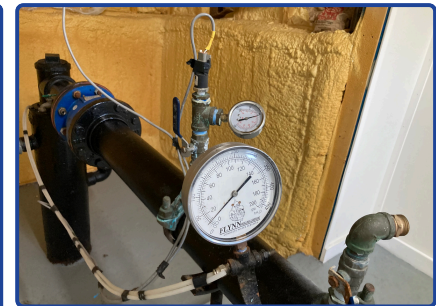
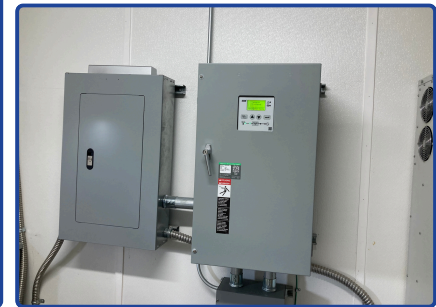
After

Today, the Terre Du Lac drinking water system is significantly stronger, safer, and more reliable—ensuring that families in the community have consistent access to clean, safe water they can trust.
