Case Study: Verde Lee

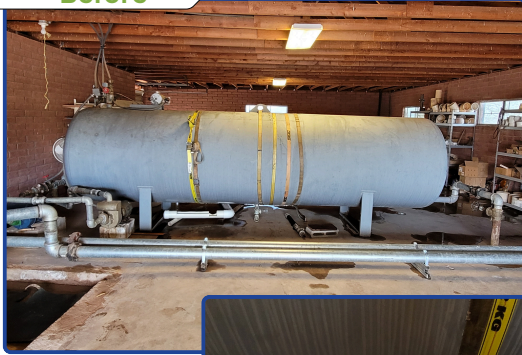
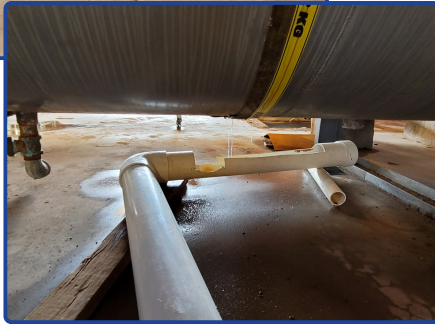
Before

When Cactus State took over the Verde Lee Subdivision's drinking water treatment facility in Greenlee County, Arizona, which was in critical condition and jeopardizing the health of the 250 households it serves. The system had a leaking hydropneumatic storage tank, hastily patched with ratchet bands, leading to water pressure fluctuations and significant water waste. Additionally, the facility's poorly maintained arsenic removal system consistently failed to meet regulatory standards, posing potential health risks to the community. The wells were operating inefficiently, plagued by incorrect pump settings and cavitation issues, which further compromised water delivery. Compounding these issues was the absence of backup power, putting residents at risk of losing access to water during power outages, and a lack of proper disinfection process, which left the water supply vulnerable to contamination.

Cactus State acted swiftly to address these critical issues. The leaking hydropneumatic storage tank was replaced, stabilizing water pressure and preventing further water loss. New piping was installed, and the wells were rehabilitated with upgraded equipment to eliminate cavitation and enhance pump efficiency, ensuring reliable water delivery. The arsenic treatment system was also upgraded and reconfigured, bringing the water quality back into full regulatory compliance. To further safeguard the system, advanced remote monitoring technology was implemented, allowing for real-time tracking of equipment performance and water levels, which enables quicker response times during emergencies. Additionally, a backup generator was installed to maintain consistent water access during power outages, ensuring that residents have continuous, safe drinking water.
