## Case Study: Pecan Lakes

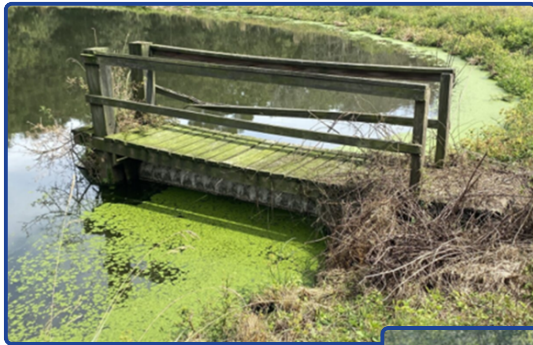
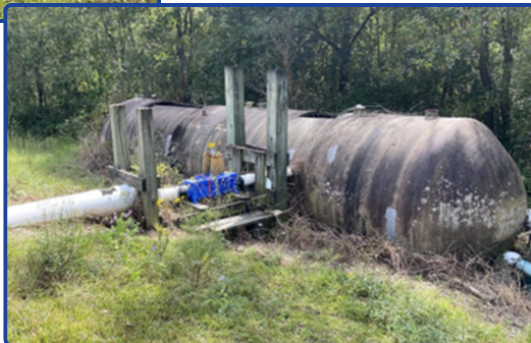
**Before**

At the time of acquisition, the Pecan Lakes wastewater system relied on a deteriorating, repurposed tank in place of a proper disinfection contact chamber. This inadequate setup failed to provide effective treatment, resulting in heavy eutrophication where flow entered Reese Creek near the discharge point. The impact on downstream water quality created a serious environmental hazard and highlighted the urgent need for rehabilitation.

Serving approximately 350 homes, the facility was completely overhauled to restore compliance and protect local waterways. The outdated tank was replaced with an appropriate disinfection system, ensuring effluent received proper treatment before discharging into the nearby area.

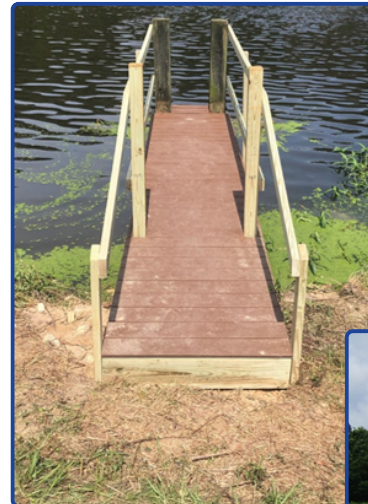
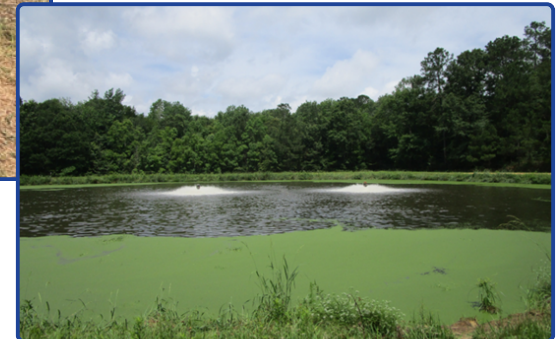
**After**

With these improvements, the Pecan Lakes system was transformed from a source of environmental concern into a stable and reliable facility. The upgraded disinfection process now safeguards both the community and Reese Creek, providing long-term protection for water quality downstream.
