## Case Study: State Park Village

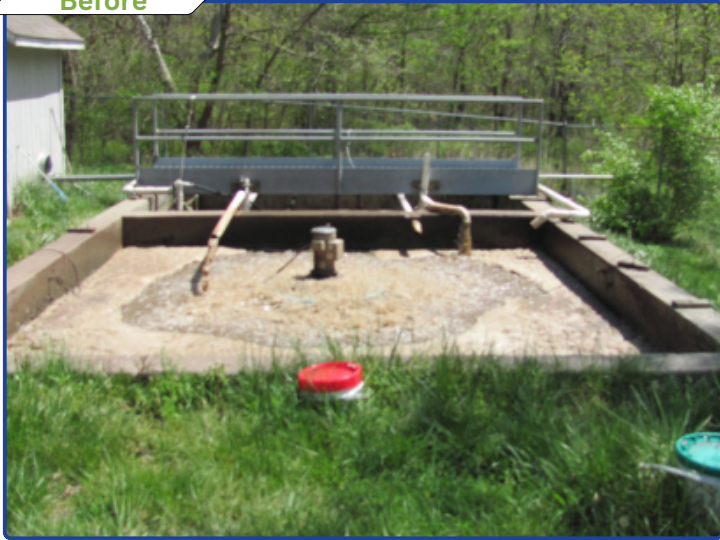
Before

At the time of acquisition, the State Park Village wastewater system was severely failing—evidenced by a two-mile sludge blanket extending through the receiving stream. The severity of the issue posed significant risks to both the community and the surrounding environment, underscoring the urgent need for a comprehensive overhaul.

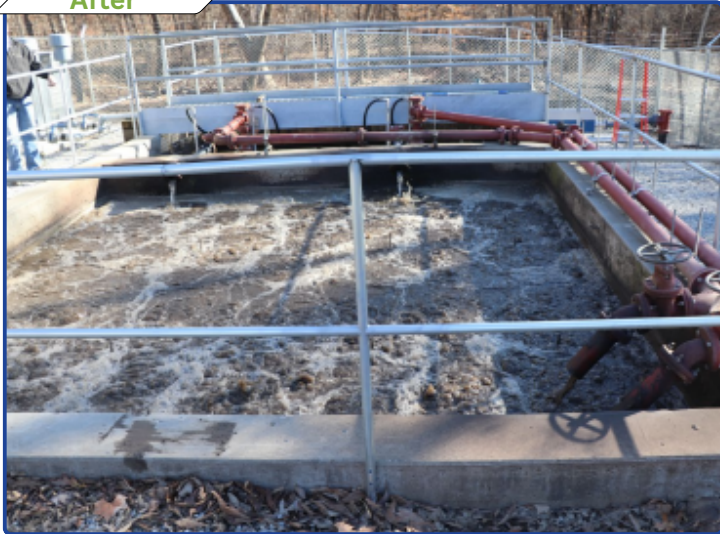
After

As a result of these enhancements, the plant's operations were transformed. What was once a failing and environmentally harmful system is now performing reliably and in compliance with regulatory standards. The upgraded system better protects local waterways and positions State Park Village for improved service and operational resilience.

To address these challenges, the facility underwent a series of targeted upgrades. Flow equalization was added to balance influent fluctuations, a screw screen was installed to prevent nuisance solids from entering the treatment basins, tankage was expanded to improve storage and treatment capacity, and an Integrated Fixed-Film Activated Sludge (IFAS) system was installed to dramatically improve treatment and nutrient removal delivering both suspended and attached growth treatment in a hybrid process, an innovative application for facilities of this size.
